# Operational Related Risks

Best Practices in Dam and Levee Risk Analysis

Part H – Other Risks

Chapter H-1

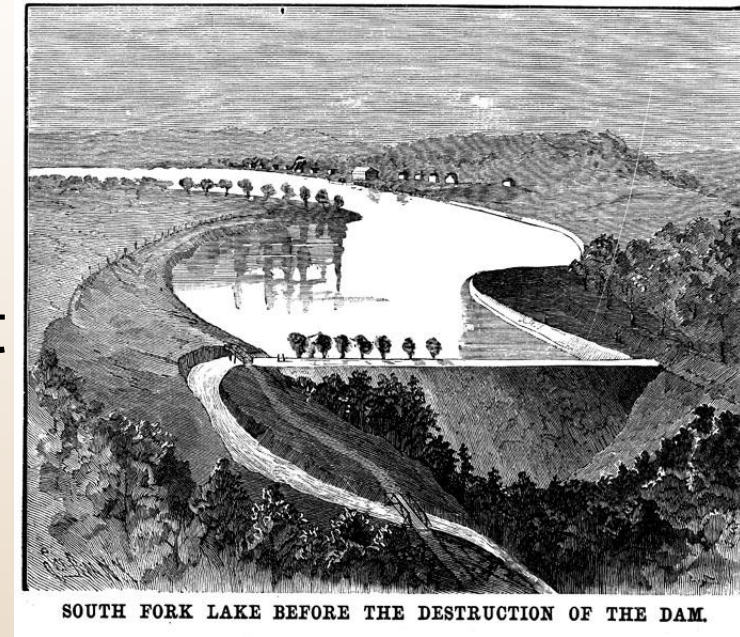
SOUTH FORK LAKE BEFORE THE DESTRUCTION OF THE DAM.

- Failed in 1862 - collapse of stone outlet conduit, reconstructed but outlet filled in
- Spillway:
  - Ungated overflow
  - 99 feet wide
  - Bridge across spillway with supports at 6-1/2 foot spacing
  - Iron Screens were placed across the spillway to prevent fish from escaping reduced spillway capacity by 40%
- Dam crest lowered to widen roadway so that carriages could pass
- No camber, center portion of dam crest lower

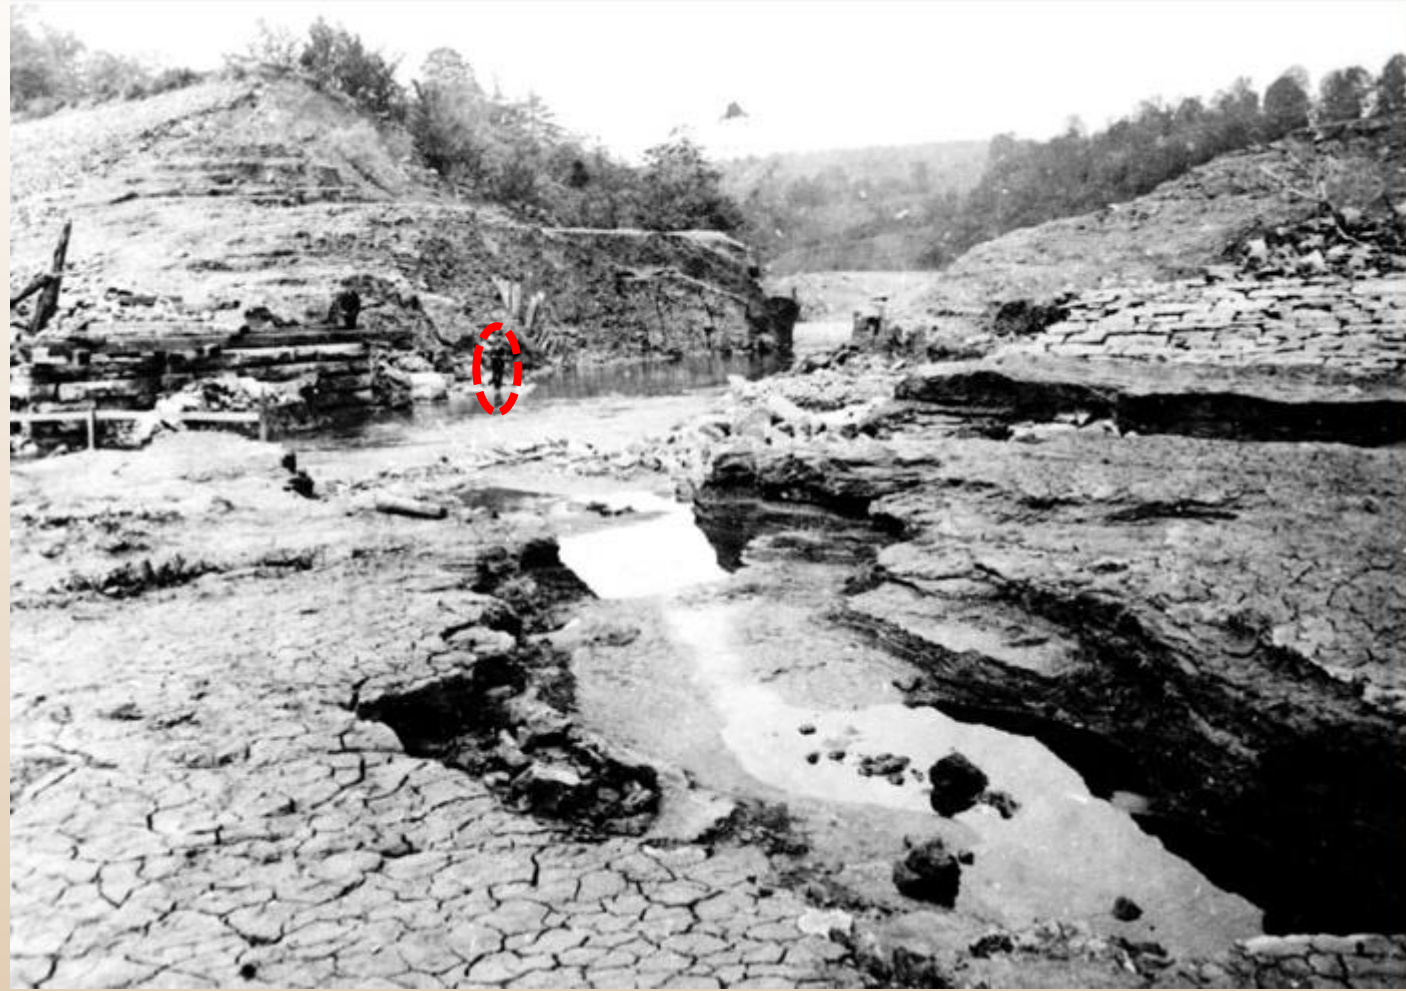
- Heavy rains in May of 1889
- Inflow greater than spillway capacity and fish screens became plugged with debris
- Dam overtopped and failed

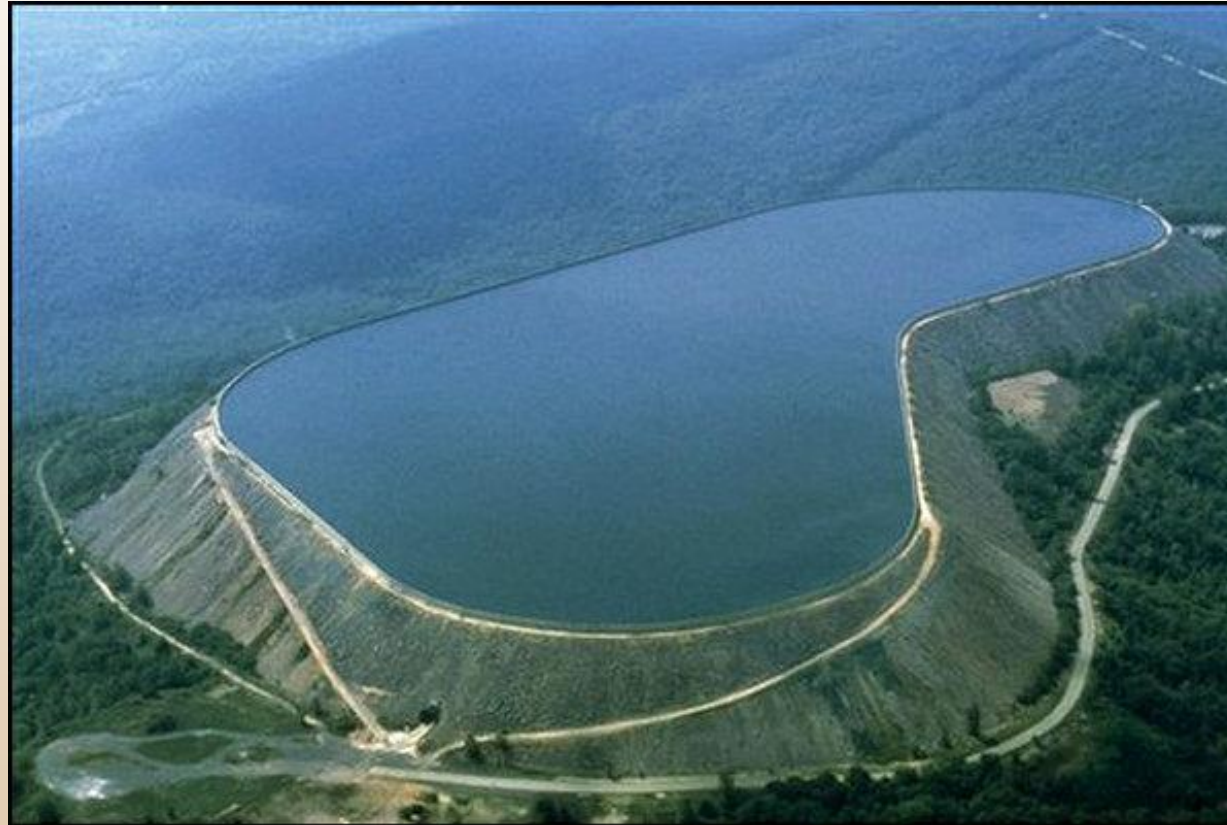
- Concrete-faced earthfill “ring-dike” structure
- Upper reservoir of pumped-storage project
- Water routinely stored on 10-foot high parapet

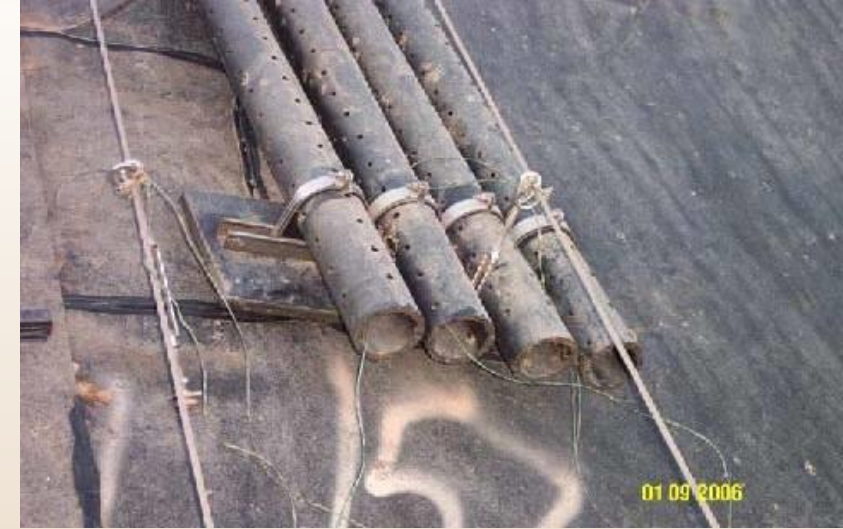
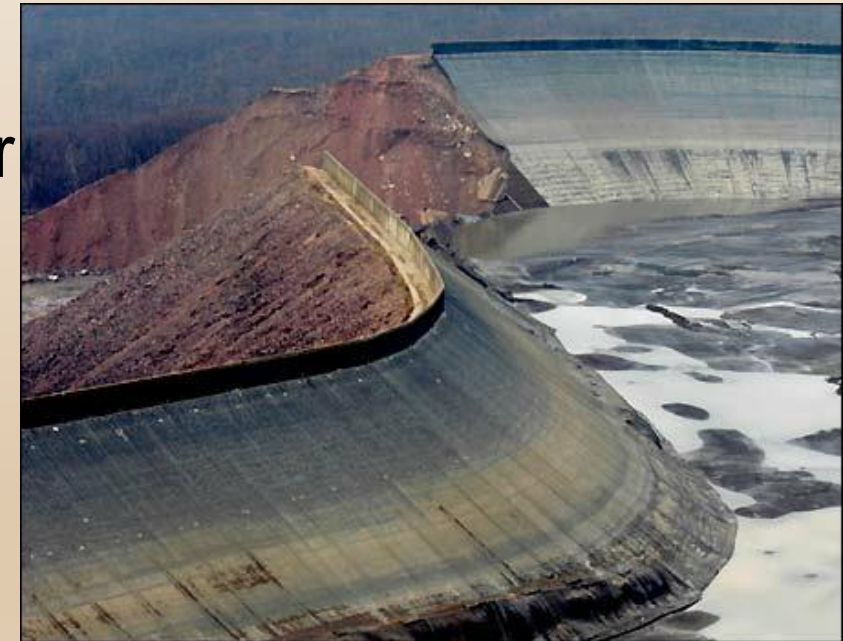
- Membrane liner installed in 2004
- Reservoir level instrumentation could not be reinstalled properly due to liner warranty issues
- Instruments were loose and not reading reservoir level properly
- Resetting of reservoir sensors did not account for settlement of embankment
- Alarms wired so high level and high-high level sensors both needed to trigger for alarm
- Over-pumping was not detected and dam overtopped and failed

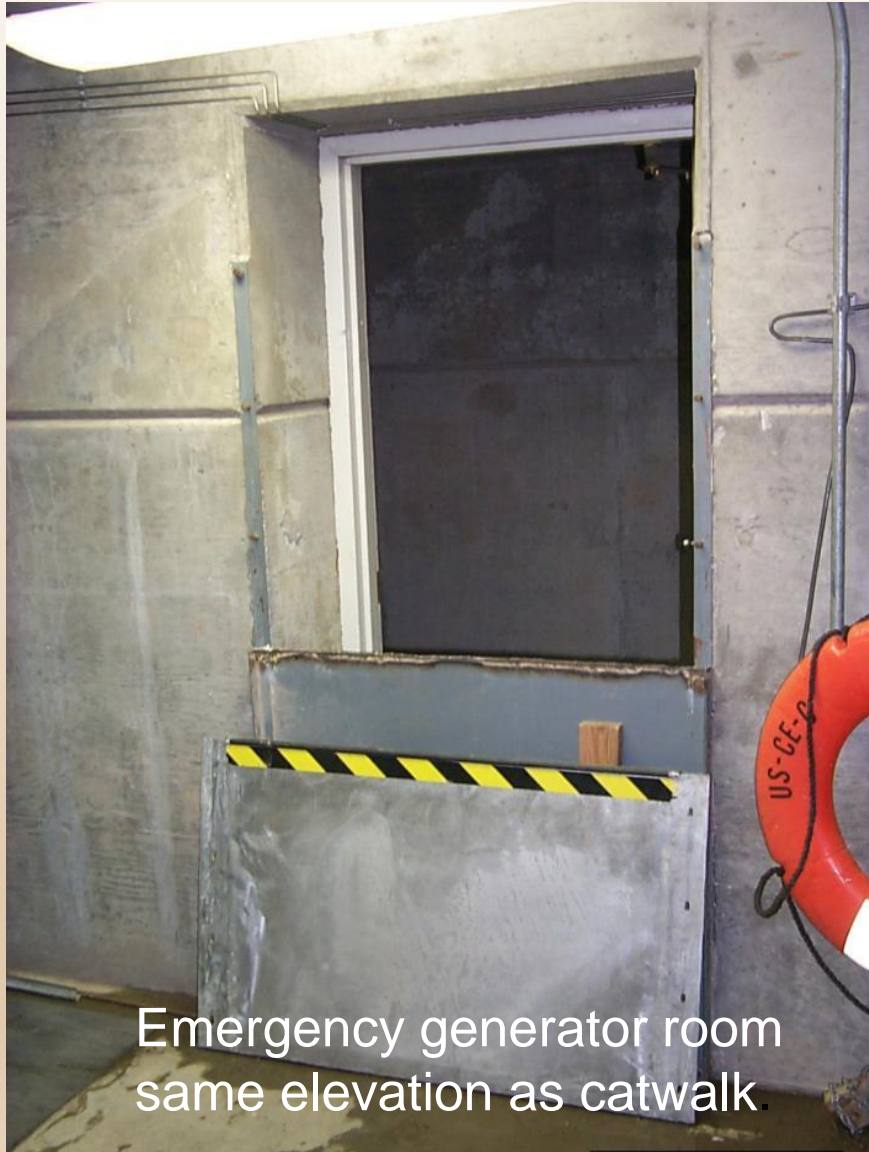
# Spillway Operating Deck and Generator Floods

Emergency generator room  
same elevation as catwalk.

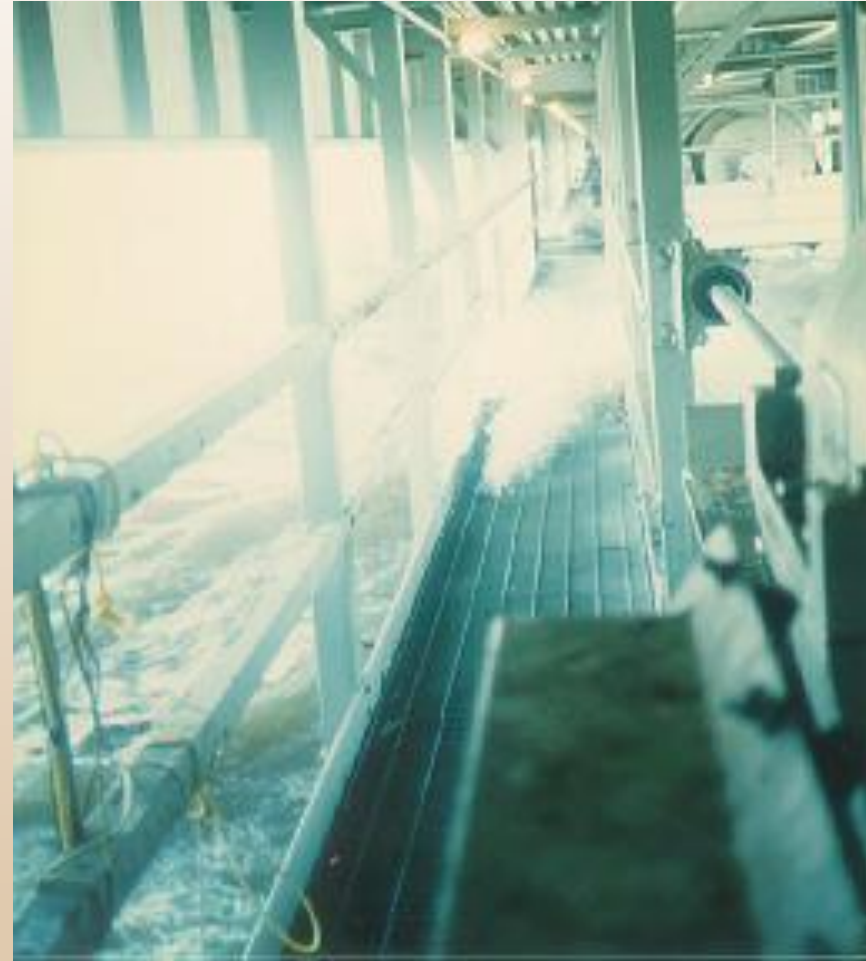
Catwalk almost inundated  
during flood – gates must be  
operated from catwalk

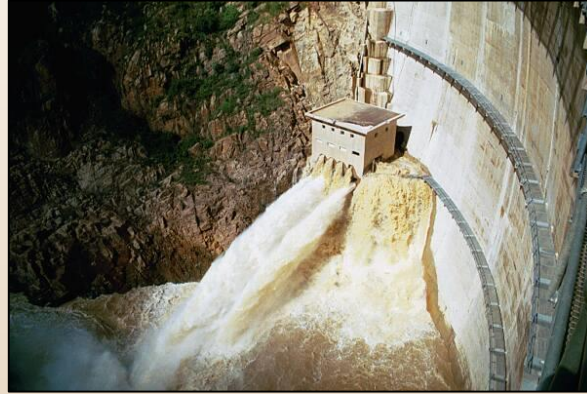
- Valve failure

- Control valve left in open position leading to fully opened gate
  - Control valve not equipped with spring loaded lever
- Software error in SCADA syst. causes gate to open unexpectedly

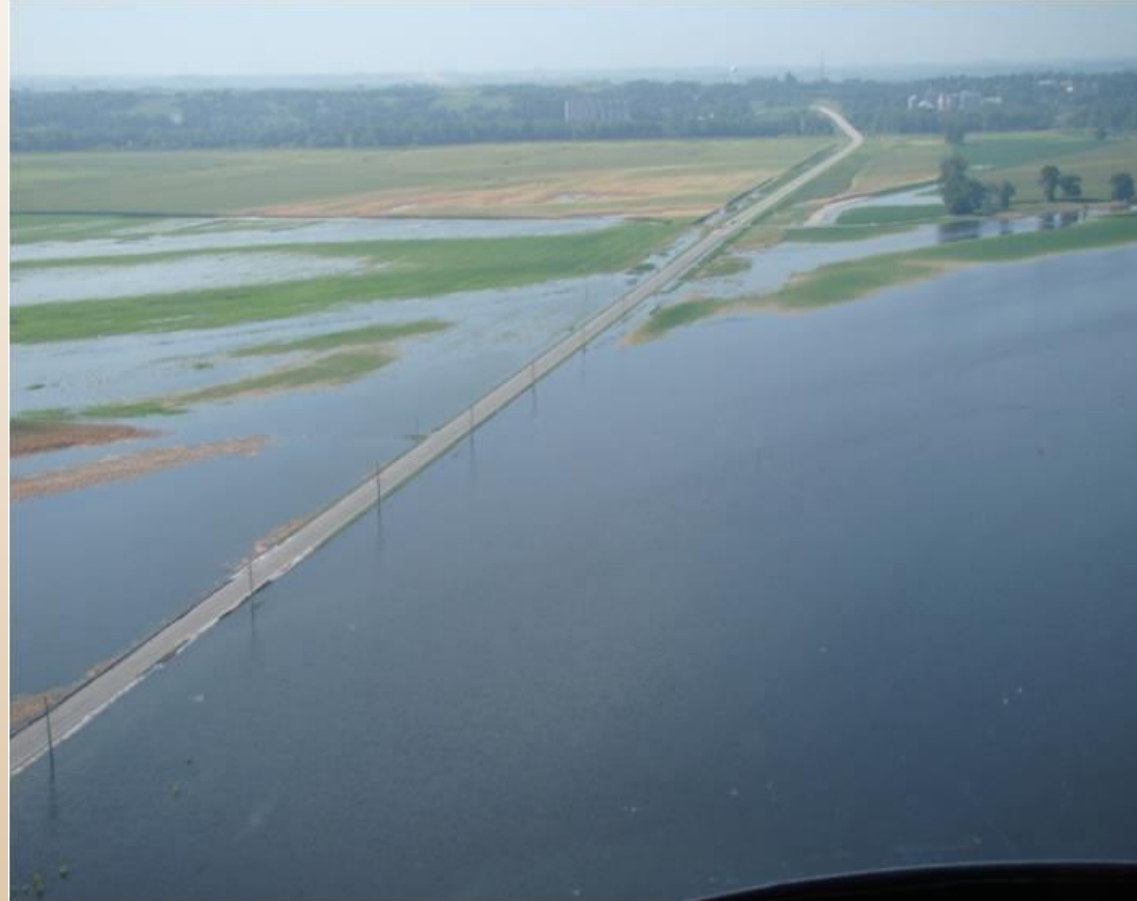
Sugar Tree Bottom Levee System

# Insufficient Pump Capacity Inundates Leveed Area

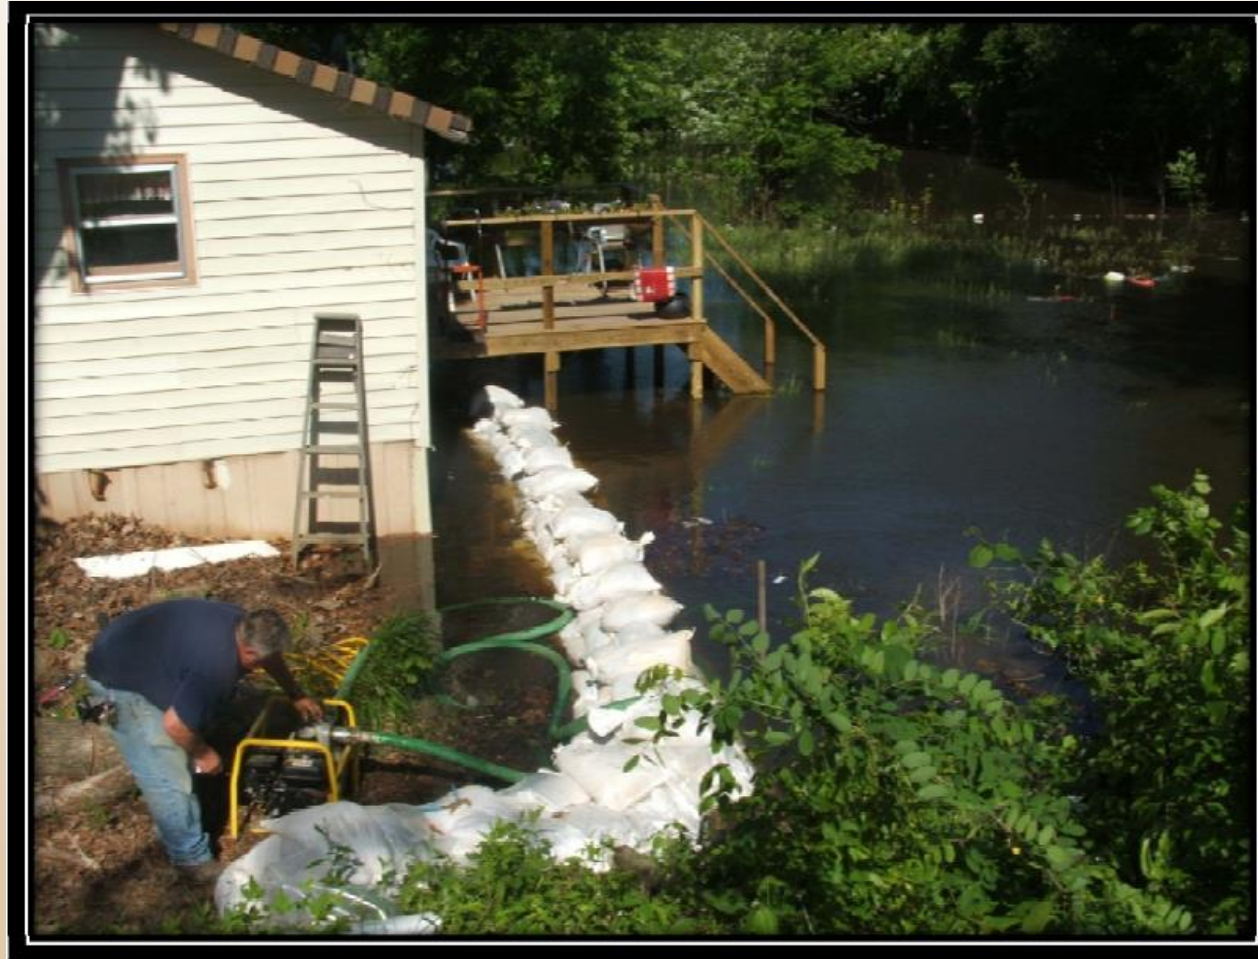
Brookport Levee System

# Backflow Through Interior Drainage Culvert Due to Failure to Close Gate

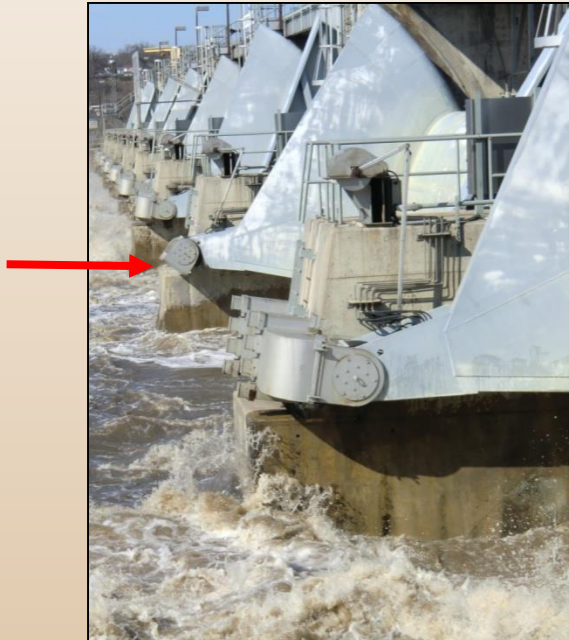
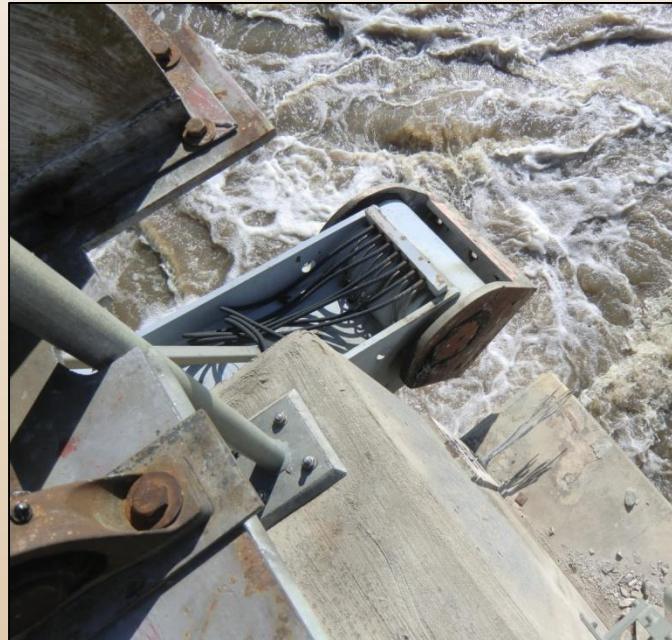
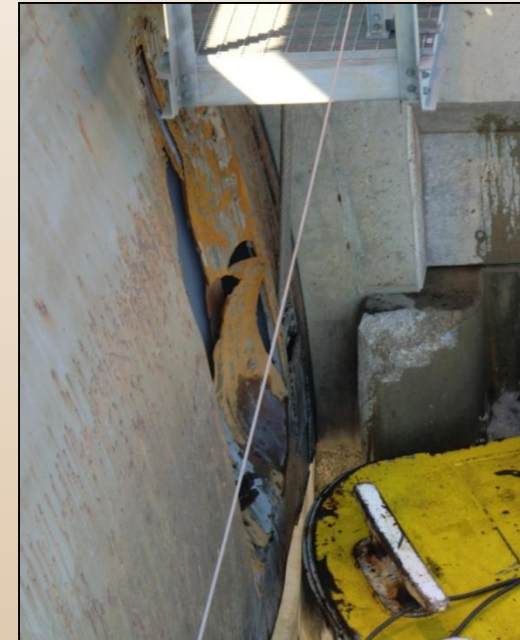
# Marseilles L&D, IL Tainter Gate Damage

- Main Dam
  - Six barges break free and three sink.
  - Gates 2 through 6 impacted by barges leaving Gates 2 and 3 inoperable
  - Pier 2 trunnion anchorage destroyed
  - Decreased spillway capacity led to erosion at dam around boiler house
- Earth Dike (Note: this structure is upstream of the main dam)
  - Erosion of earth section
  - Widespread residential flooding

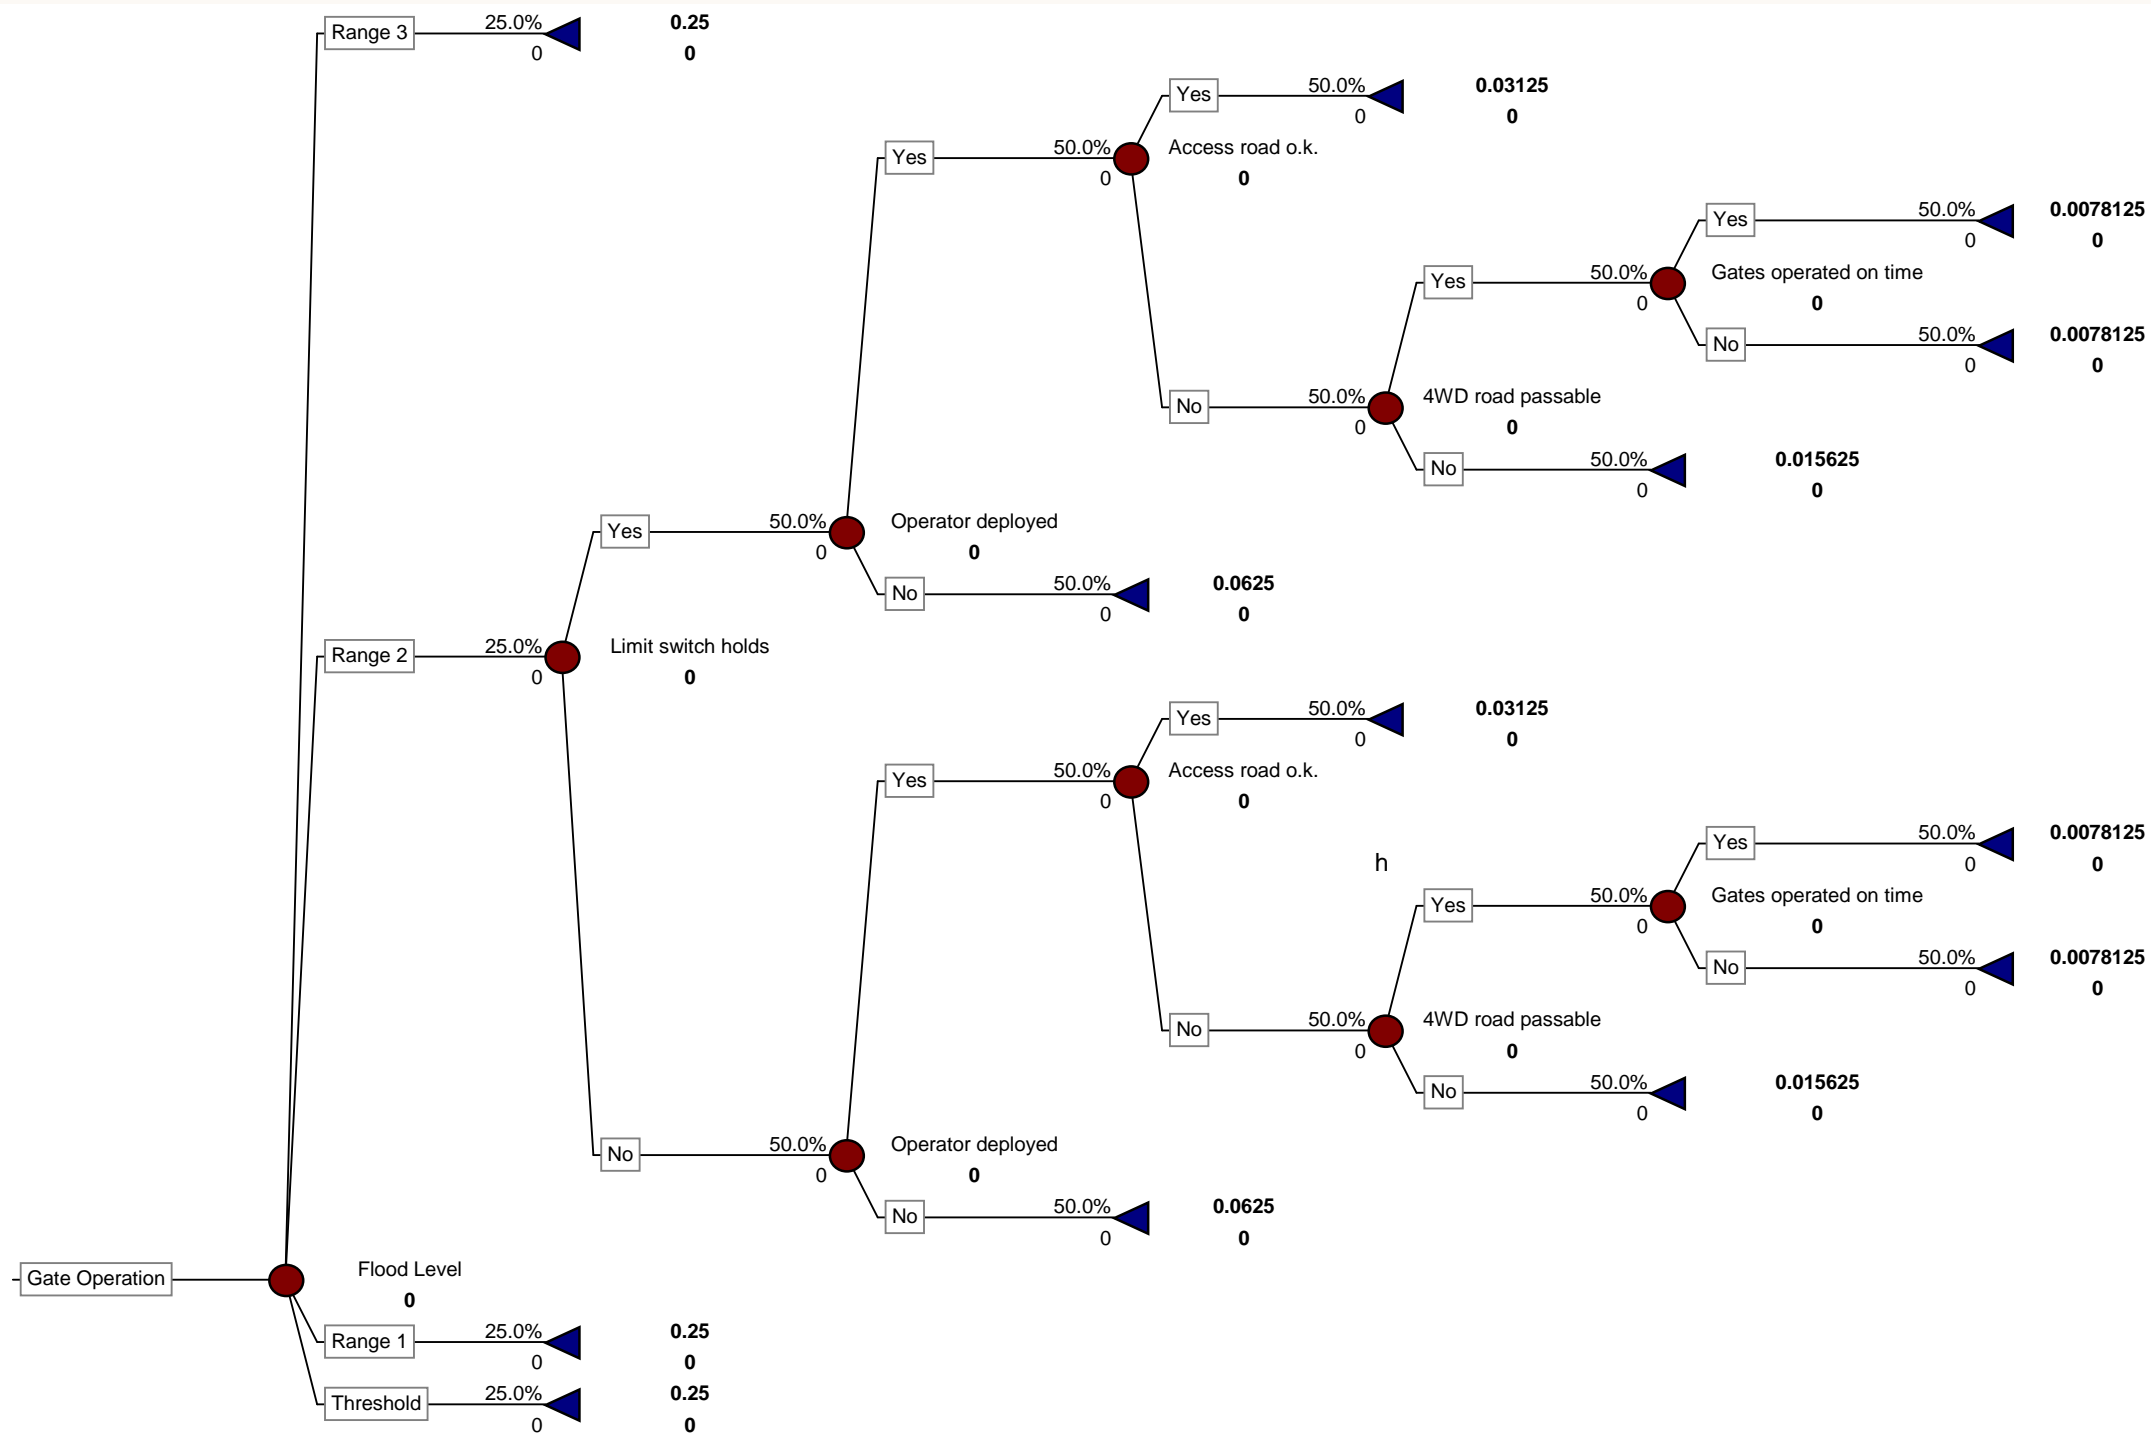
Operational events

# Typical Portion of Event Tree

- ↳ Reservoir loading (partition)
  - ↳ Initiation - Limit Switch Fails
    - ↳ Operator Deployed
      - ↳ Main Access Road Impassable
        - ↳ Secondary (4WD) Road Impassable
          - ↳ Gates Not Operated on Time
            - ↳ Embankment Dam overtops
              - ↳ Erosion Initiates
                - ↳ Crest breaches
                  - ↳ Dam breaches (uncontrolled release of reservoir)
